Renovation Work of Facilities for Tokyo Metropolitan Government Bureau of Sewerage

— Renovation, Measures against Post-Earthquake Energy Shortage, Measures against Climate Change, Introduction of On-Site ICT —

Hiroshi Kikuko,
Yukio Ando,
Kaoru Goto,
Kazutaka Yamawaki

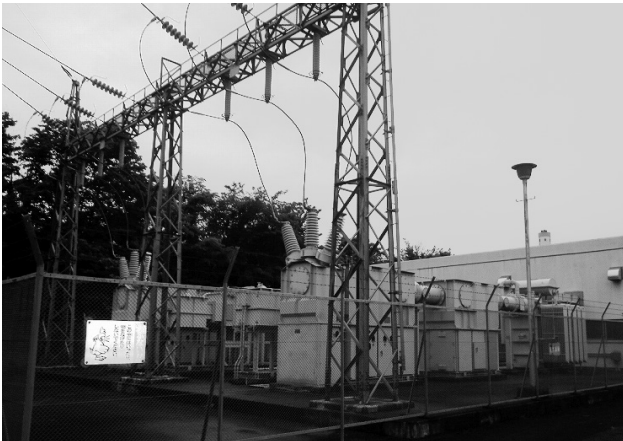
Fig. 1 Existing V-sub

Renovation work was carried out due to performance deterioration over 30 years of operation.

We renewed 66kV ultra-high voltage power receiving and distribution facilities (2-line power receiving (main line and backup line) at the Minami-Tama Water Reclamation Center. Existing equipment was composed of two 7500kVA oil-immersed power transformers and a unit-type gas-insulated switchgear (V-sub). These equipment units were changed to a 72kV cubicle type dry-air insulation switchgear (Eco C-GIS), which is our first product to be release. The Eco C-GIS employs dry air for its insulation medium so no SF6 insulation gas is used inside. This model is very environmentally-conscious. [Fig. 1](#) shows a view of the existing V-sub and [Fig. 2](#) shows a newly installed Eco C-GIS.

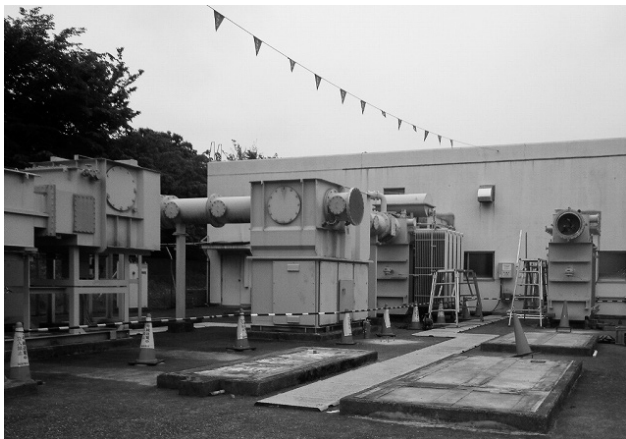
Fig. 3 Work Situation near Renovation Construction Work

A view of the safety measures taken during the work is shown. The work was conducted close to energized equipment.

First, we installed a blockade between No.1 and No.2 substation equipment. Except for unavoidable cases, we strictly maintained a “no trespassing” policy at the energized substation area. If access was needed, it was done with the cooperation of our on-site staff in order to avoid anyone getting too close to the energized equipment or compromise safety. [Fig. 3](#) shows a view of work situation near renovation construction work.

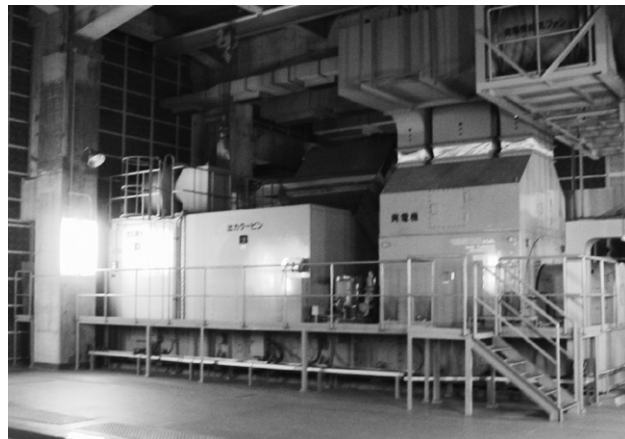
Fig. 5 No.1 Existing 12,500kVA (Gas Turbine) Generator System

After 30 years since the installation, performance deterioration was found to be serious and renovation work was carried out.

Formerly, the emergency power supply for the Mikawashima Water Reclamation Center was fed by a 12,500kVA emergency gas turbine generator (No.1 machine) installed around 1979. Along with a recent increase in the volume of processing water, however, the second Asakusa-line Pumping Station came into operation, which led to the addition of another 25,000kVA gas turbine generator facility in 2009 in order to secure a stable emergency power supply. Further in 2014, renovation work was carried out to install a 25,000kVA gas turbine generator, thus establishing a two-unit emergency power system. At that time, the first 12,500kVA gas turbine generator (see **Fig. 5.**) was removed because it had suffered from extreme performance deterioration after 30 years of operation.

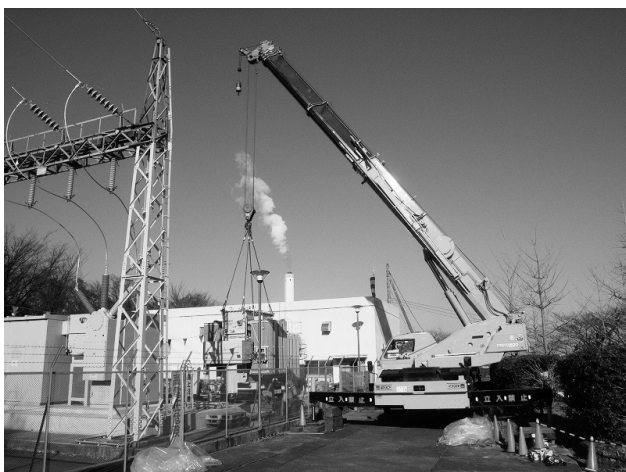
Fig. 4 Crane Work during Carry-in and Carry-out Period

Preventive measures were taken to prevent abnormal close contact to live wires.

CAUTION plate in a position where the crane operator can see it in order to warn of the limited approach distance. During crane construction work, a dedicated employee was assigned to the site with the specific detail to help prevent any encroachment to the danger zone. To avoid miss-operation, we adopted a crane equipped with a swivel preventive function controlled by computer and worked with this safety measure. **Fig. 4** shows a view of crane work during carry-in and carry-out period.

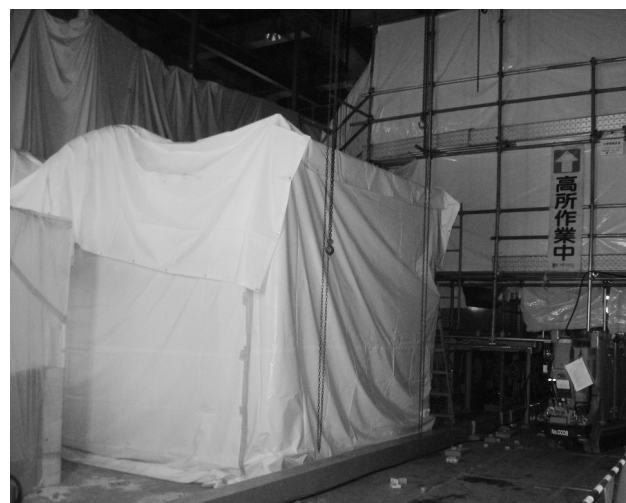
Fig. 6

Designated Controlled Area Covered with a Flameproof Sheet during Work Using Heat or Flame

When the work involves the heat or flame for unavoidable reasons, the surrounding area was surrounded by a flameproof sheet. Such work was carried out in a space covered with the sheet.

Select ventilation was used within the designed area and dedicated supervisory staff were present during such work. After each cutting work, the staff rechecked for presence of smelting embers for 30 minutes.

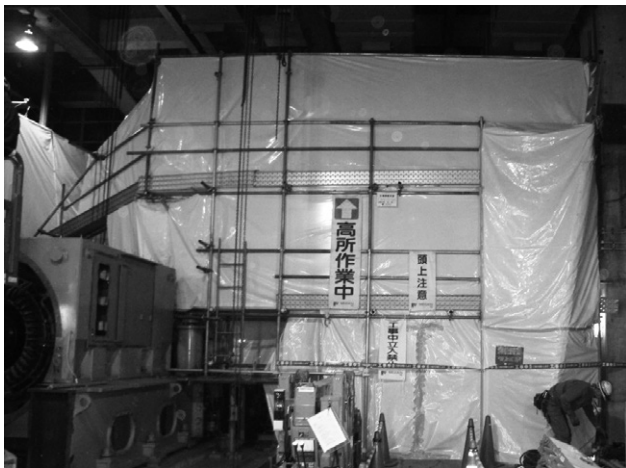
Fig. 7 Removal of Asbestos from Turbine Engine

The whole engine was covered with a flameproof sheet and asbestos removal work was then carried out.

The whole engine was sectioned and removal work was conducted in designated controlled area (see Fig. 7.).

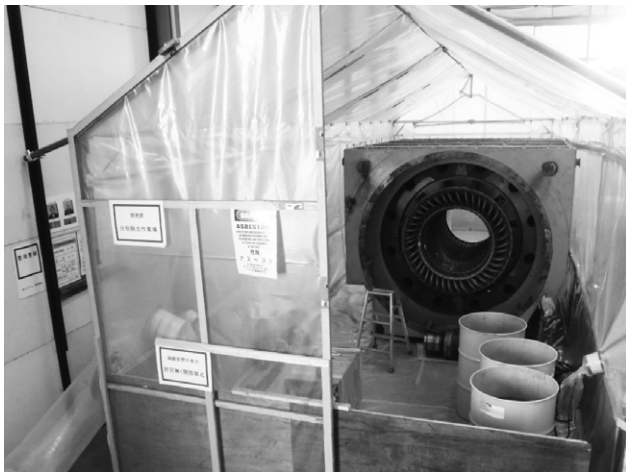
Fig. 8 Removal of Asbestos from Generator Main Body

Resin used for generator windings was found to contain asbestos. The removed generator was taken back to the factory and asbestos removal work was carried out within the designated controlled area.

Portions containing asbestos were brought back to our factory. We set up a designated controlled area. Where asbestos was removed (see Fig. 8.).

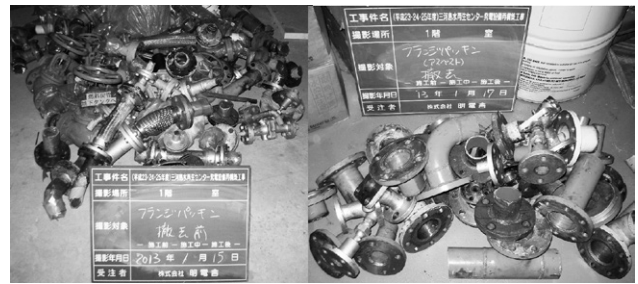
Fig. 9 Removal of Asbestos from Flange Gaskets of Fuel Pipes

The front and rear parts of each duct flange were cut off and the fuel pipes (after being cut) were brought into the designated controlled area where their gaskets containing asbestos were removed.

After the front and rear parts of a pipe flange were cut off, they were transported without breaking the flange. Inner gaskets were removed within a designated controlled area on site (see Fig. 9).

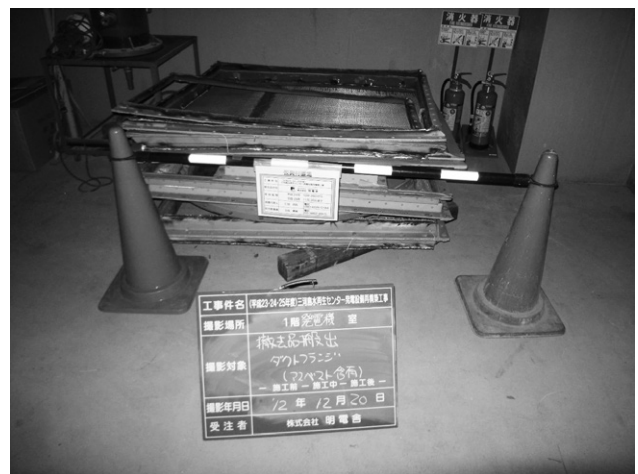
Fig. 10 Disposal of Flange Gaskets from Air Conditioner Ducts

Since they were known to contain stabilized asbestos, they were disposed of without breaking the flange bodies.

The front and rear parts of the duct flange were cut off and handled carefully without breaking the flange. This industrial waste was disposed of as a stable asbestos contained material (see Fig. 10).

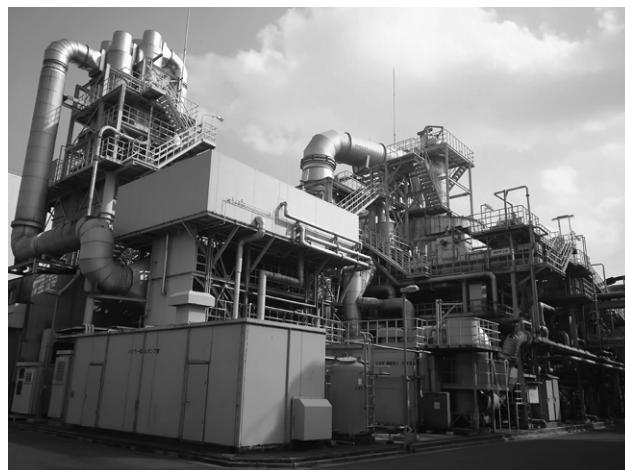
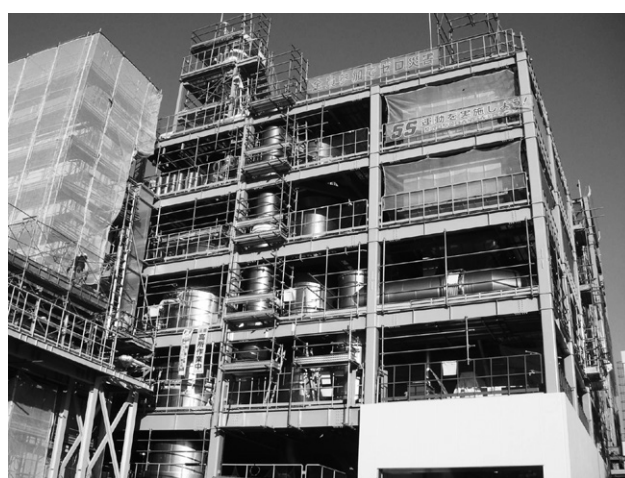
Fig. 12 Installation Situation of Existing and New No.3 Incinerators

An installation view of the existing foam fluidized bed furnace (200t/day) before removal work is shown in (a) and the installation of new turbo type fluidized bed furnace (250t/day) is shown in (b).

down to the shortest amount of time: thus the operation of new turbo furnaces started and the existing first-generation incinerators, once called the biggest scale facilities in the East, would be abolished one after another. Fig. 12 shows the installation of an existing and new No.3 incinerators.

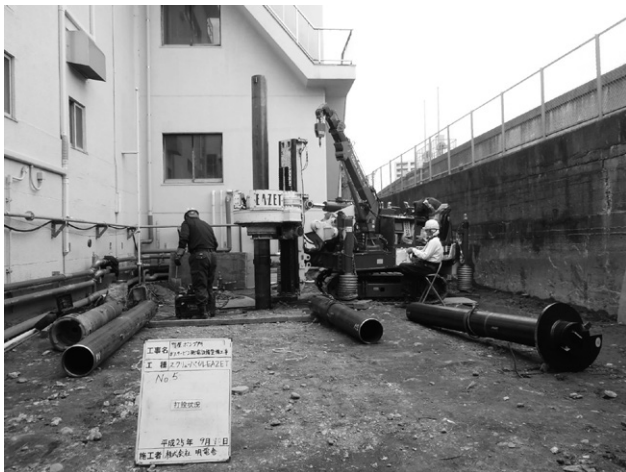
Fig. 14 Piling Work for the Generator Foundation

A view of piling work is shown. The work was performed close to subway shield structures.

Steel pipe piles were driven as deep as 28 meters down into the hard layer. In fact, subway shield structures were crossing beneath the pumping station. Since the project work had to be carried out extremely close to the structures, only 1.8 meters at the closest, we had several meetings parties, the TMG Bureau of Sewerage, and a subway-related firm. This was to determine the piling positions. At the time of the work near the subway shield structure, representatives from the Bureau of Sewerage and a subway-related firm observed the work on site. Piling work was thus conducted with the utmost care. The subway network is one of the most important social infrastructures. We finished the piling work safely without causing any damage to the shield structures. **Fig. 14** shows a view of piling work for the generator foundation.

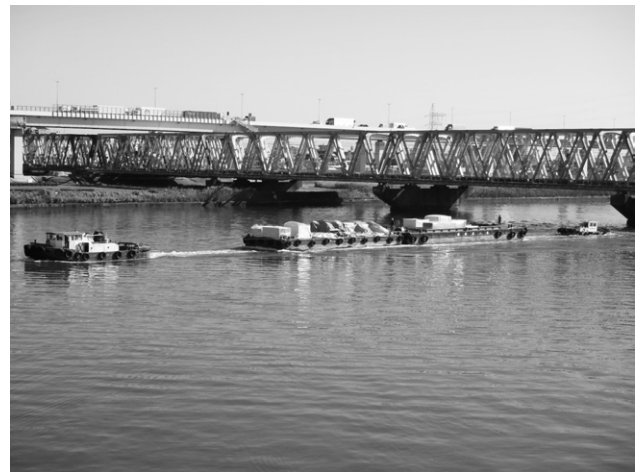
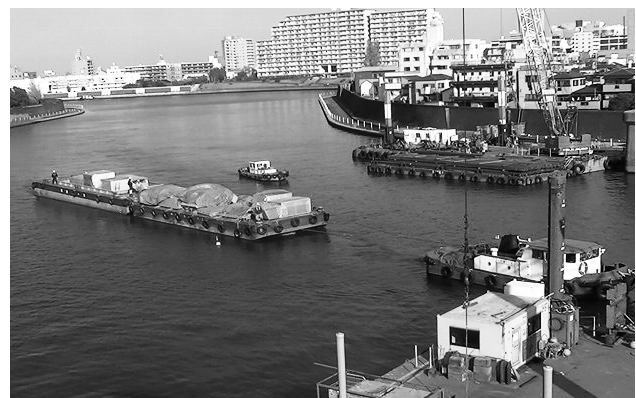
Fig. 15 Generator System Transportation by Barge

A view of transportation on the river is shown in (a) and the transportation near the pumping station is shown in (b).

type barge with a hollowed inside. We tried to minimize generator system disassembly level in order to save on-site reassembly time after the equipment was delivered. The disassembled enclosures and suction/exhaust hoods were transported on a flat barge. **Fig. 15** shows a view of the generator system transportation by barge.

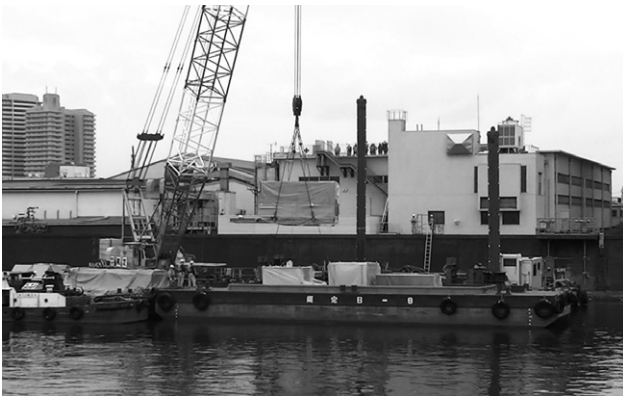
Fig. 16 Generator System Transportation by Barge

A view of the generator system lifting and carry-in by using a 100t crane barge is shown.

by the waves each time there was a wake from traffic of other ships. We thus were challenged in the equipment installation and adjustments. This carry-in work was uncommon and it was impossible by a conventional method. By thinking outside the box, we thought of the idea to use the river more effectively by making the transportation, carrying-in work, and installation of equipment more successfully. Fig. 16 shows a view of generator system transportation by barge.

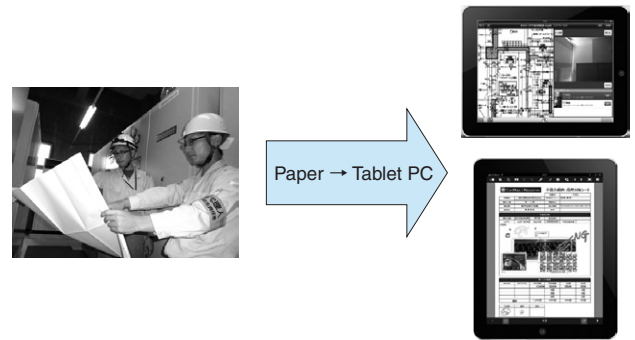
Fig. 17 Example of Active Use of Tablet PC

The contents of drawings, report form, and check lists used on the project site were digitized from paper for the tablet PC. By this digitally, we aim to improve the work efficiency.

Fig. 17 shows an example of active use of a tablet PC. The contents of drawings, report form, and check lists used for the project site were designated from paper for the tablet PC. In so doing, we simplified safety control for the security on site and improved quality control. As a result, overall work efficiency was improved. By using the special drawing management software and report form management software, our intent was to reduce the tasks to check lists, record test data, and write patrol reports

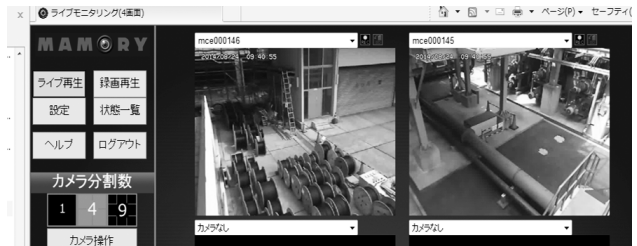
(a) A webcam connected to the cloud network

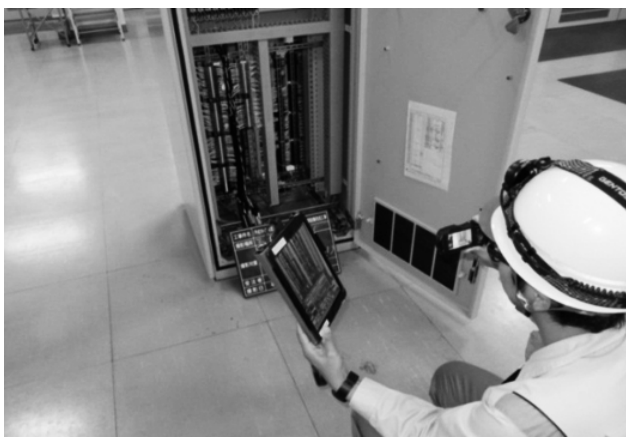
Fig. 19 Example of Active Use of Report Form Management Software

(b) Views by webcams connected the cloud network

(b) A view of checking the work done

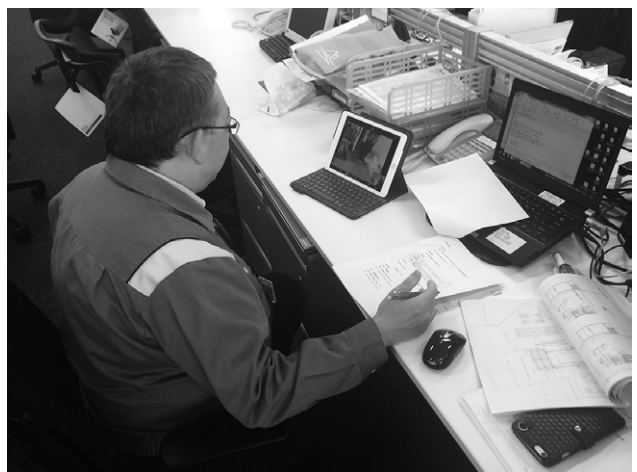
Fig. 22 Example of Active Use of Communication Tools

A communication tool is actively utilized between our safety management section and the project site office. It is monitoring equipment carry-in work.
